SERVICE BULLETIN

SUBJECT: SIDEWALL UNDULATIONS IN RADIAL PASSENGER TIRES

INFORMATION SERVICE BULLETIN

SIDEWALL INDENTATIONS IN RADIAL TIRES

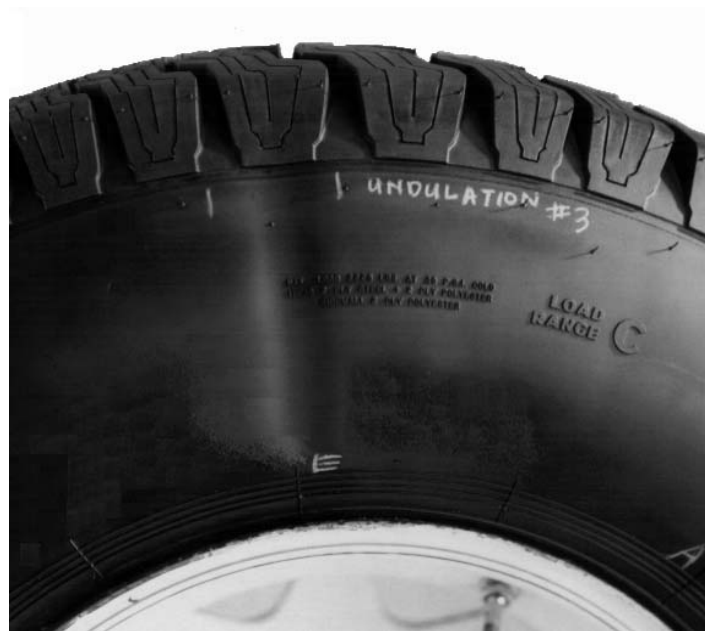
The condition, sometimes referred to as sidewall undulations, is a common characteristic of radial tire construction (see photo). These indentations are more noticeable in larger/wider radial-ply tire sizes and become more visible with higher inflation pressures.

In a radial tire the body ply cords run straight across the tire from bead to bead. Because of the "straight across" constructions, the joining of the ply material creates a narrow overlap of ply cords in the radial direction at each junction. These overlapped ply cords slightly restrict the natural expansion of the sidewall when inflated. This results in an indentation. Since all radial tires contain belts, which restrict the tread and keep it flat, only the sidewalls are indented.

Sidewall indentations are purely a visual characteristic and will not affect the performance of the tire. If bulges, rather than indentations, appear on the sidewall or if there is any question concerning the sidewall appearance, the tire should be removed from service. A knowledgeable tire dealer or the manufacturer's representative should be contacted.
